UP2413 - Landmark Apartments Lighting Transformer Notice

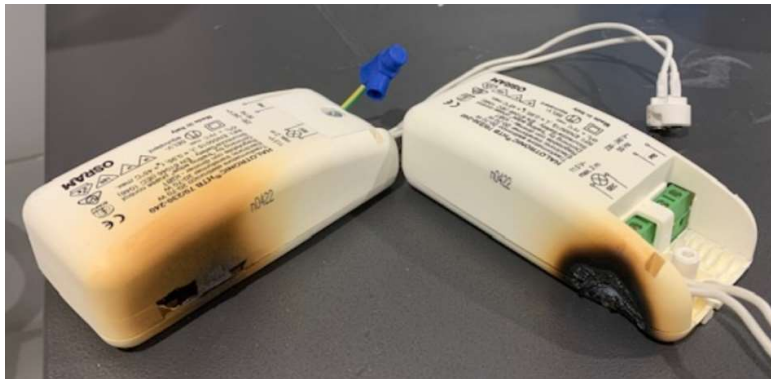
An apartment that recently upgraded to LED lighting from the originally installed halogen lights found the old transformers were charred when removed from the ceiling cavity.

It is highly recommended that any original quartz halogen downlights be replaced with LED alternatives as soon as possible.

Every light fitting/transformer MUST be visually inspected for signs of heat damage by a licensed electrician. Immediate replacement of any heat damaged transformers is strongly recommended. It is cheaper to replace the entire fitting than just the transformer.

Some previously performed LED upgrades were a simple replacement of halogen lamps to LED lamps, using the old transformers. These old transformers and roof spaces must also be checked for signs of scorching or excessive heat.
